ENVIRONMENTAL IMPACT ASSESSMENT REPORT

Bruintjieslaagte Dam – Devil's Creek –
Schoemanskloof

PROJECT DETAILS	
TITLE	Bruintjieslaagte Dam – Devil’s Creek – Schoemanskloof
REPORT STATUS:	Environmental Impact Assessment Report (public review)
LOCATION:	Bruintjieslaagte 465 JT Schoemanskloof, City of Mbombela, Mpumalanga. The site is located south west of the N4 Schoemanskloof road on the Devil’s Creek which is a tributary to the Crocodile River.
SG 21 DIGIT CODE:	T O J T 0 0 0 0 0 0 0 0 0 0 4 6 5 0 0 0 0 0
EAP:	Enpact Environmental Consultants CC PO Box 12027, Nelspruit, 1200 Tel: 013 752 6766 Fax: 088 013 7526766 E-mail: info@enpact.co.za
REPORT COMPILED BY:	Heinrich Kammeyer Enpact Environmental Consultants CC E-mail: heinrich@enpact.co.za
APPLICANT:	Joubert Family Trust Contact: Mr Lionel Eva PO Box 29, Schagen, 1207 Tel: 083 227 2415
REPORT PREPARED FOR SUBMISSION TO:	Mpumalanga Department of Agriculture, Rural Development, Land and Environmental Affairs: DARDLEA Ehlanzeni District Offices The Directorate: Environmental Impact Management 18 Jones Street Nelspruit, 1200

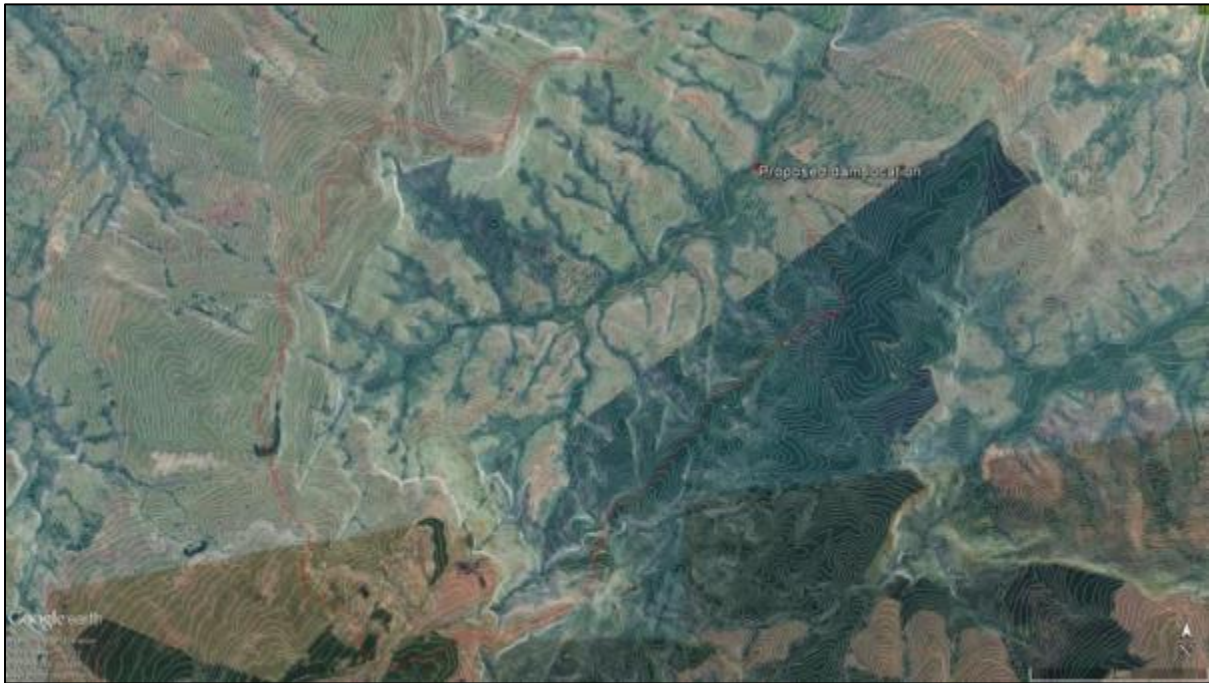
Figure 4.1.1 Topography of dam catchment

Open valley in a mountainous area with steep slopes. Devil’s Creek, with several tributaries, draining the catchment area towards the north and Crocodile River. The watershed is on approximately 2000m-, the dam at 1100m- and the confluence with the Crocodile River at 870m- above sea-level.

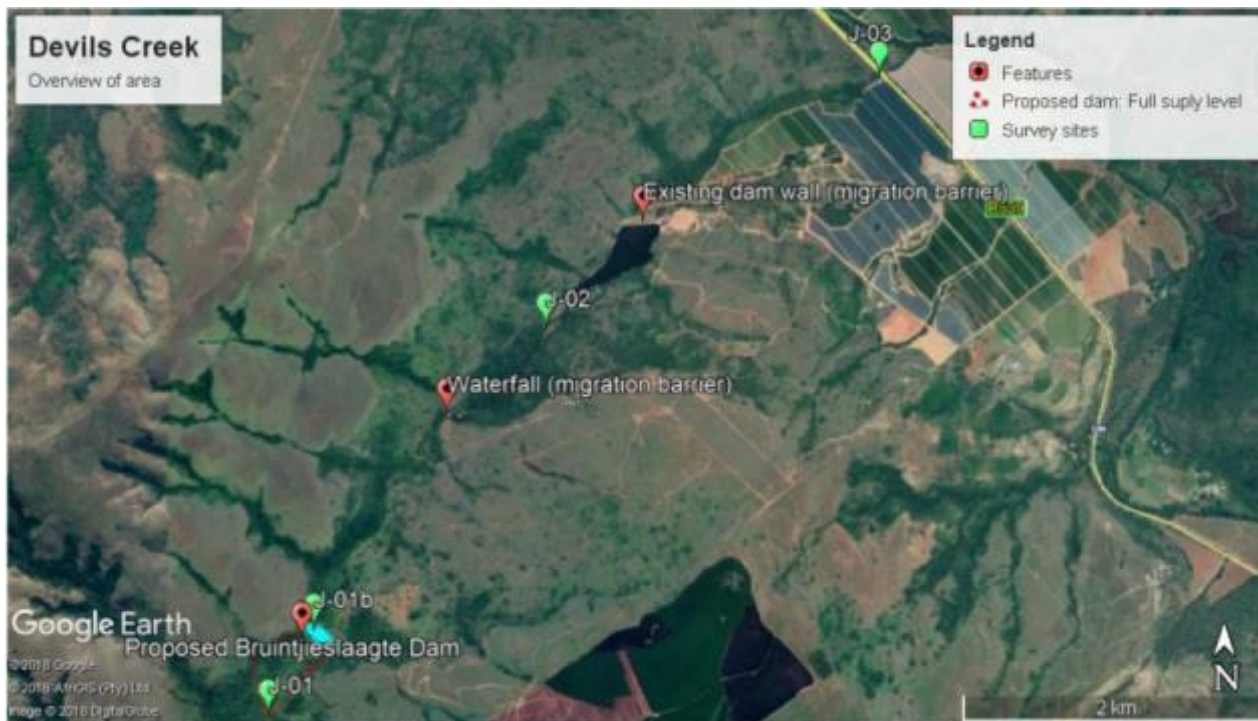
Figure 4.3.1 Devils Creek study area indicating proposed dam site, existing barriers and 2017 fish sampling sites

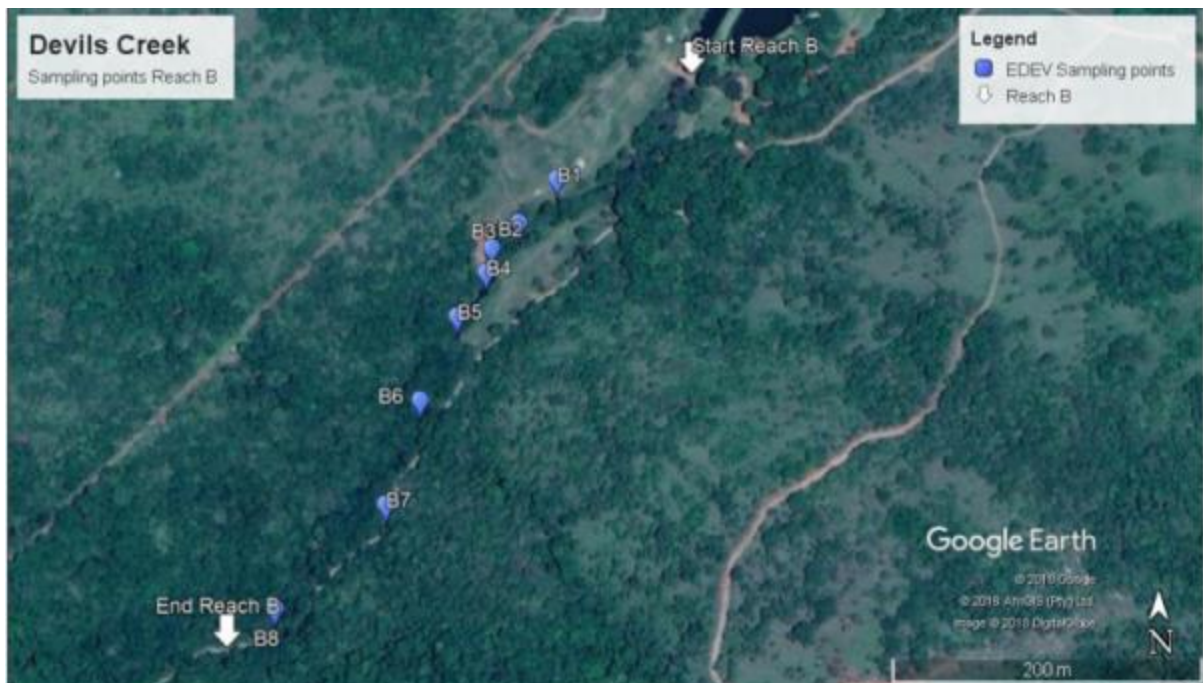
Figure 4.3.3 Devils Creek reach B (between waterfall and existing dam) indicating habitat sites where EDEV was sampled and detailed habitat descriptions were done during 2018 specialist study

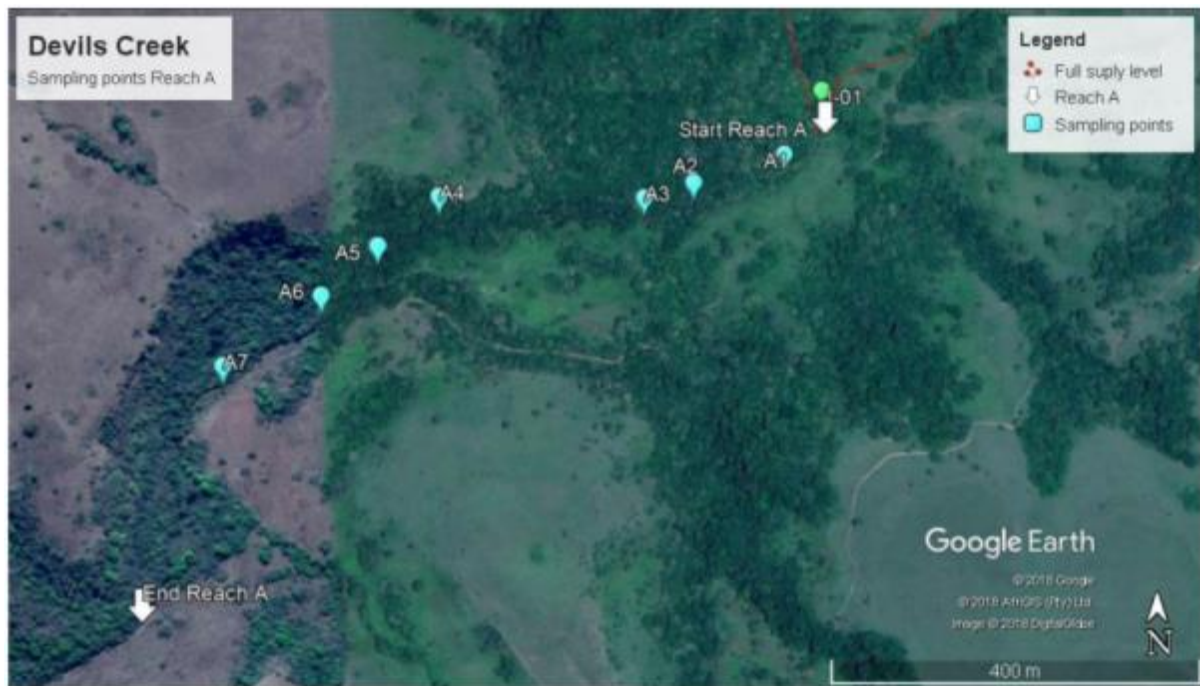
Figure 4.3.4 Devils Creek reach A (above waterfall and full-supply level) indicating various habitat sites (sampling points) where detailed habitat assessments were done during 2018 specialist study

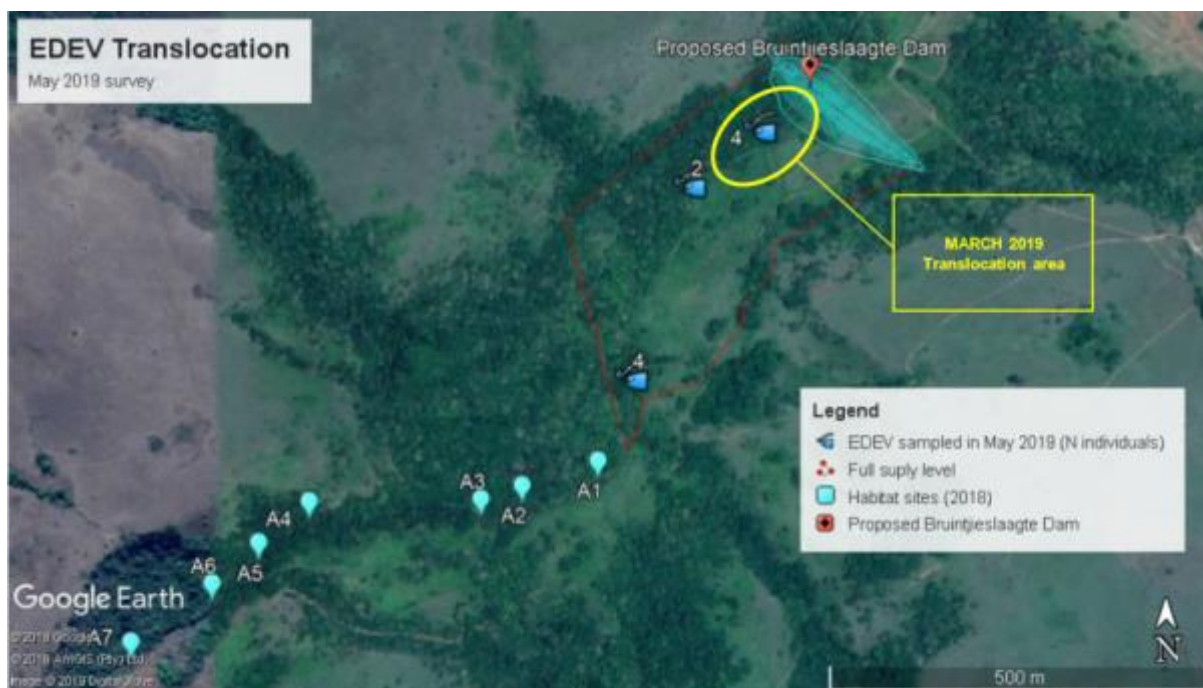
Figure 4.3.5 Number and location of EDEV individuals sampled in May 2019 in relation to proposed dam wall, dam basin and habitat sites in Reach A

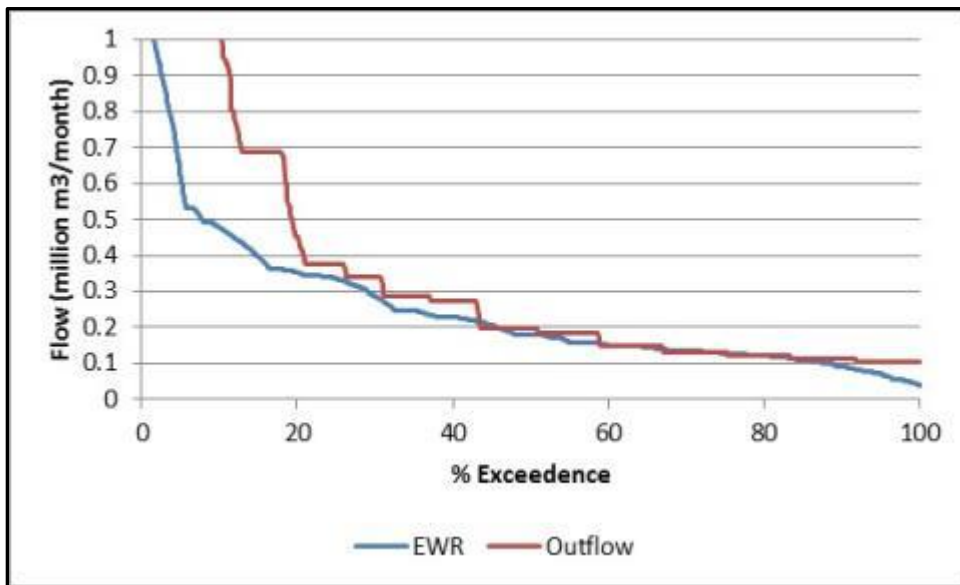
Figure 4.4.6 Outflow and EWR requirements: Bruintjieslaagte Dam

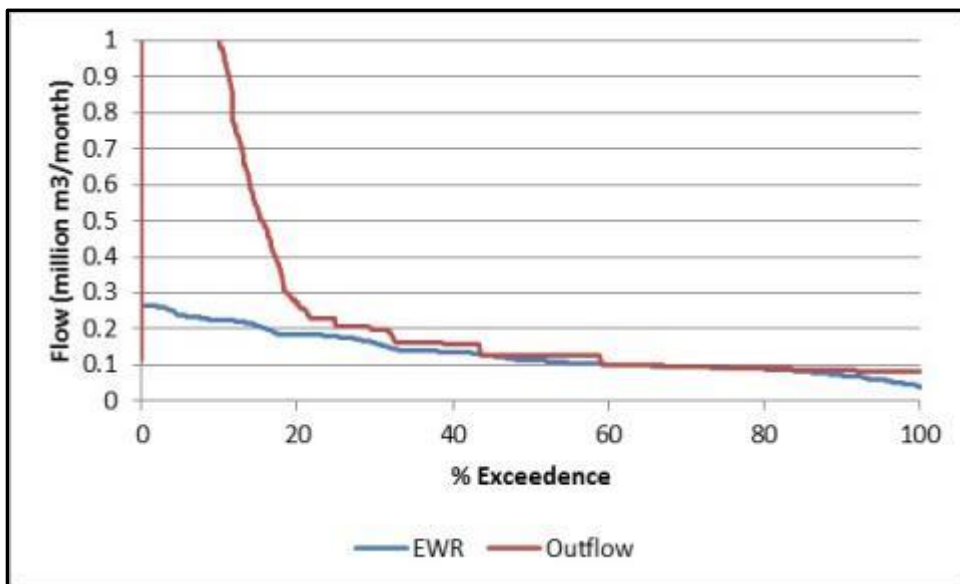
Figure 4.4.7 Outflow and EWR requirements: Koedoeshoek Dam

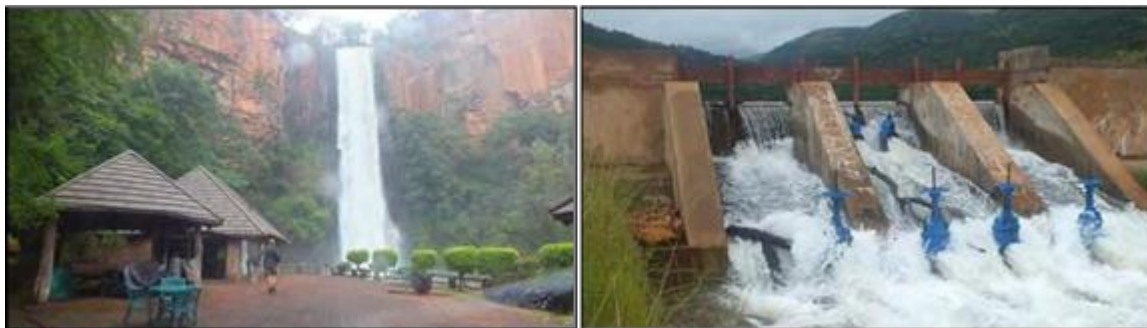
Photo 4.5.1 Fish Migration Barriers in Devil's Creek: Waterfall (A), and Existing Dam (B)

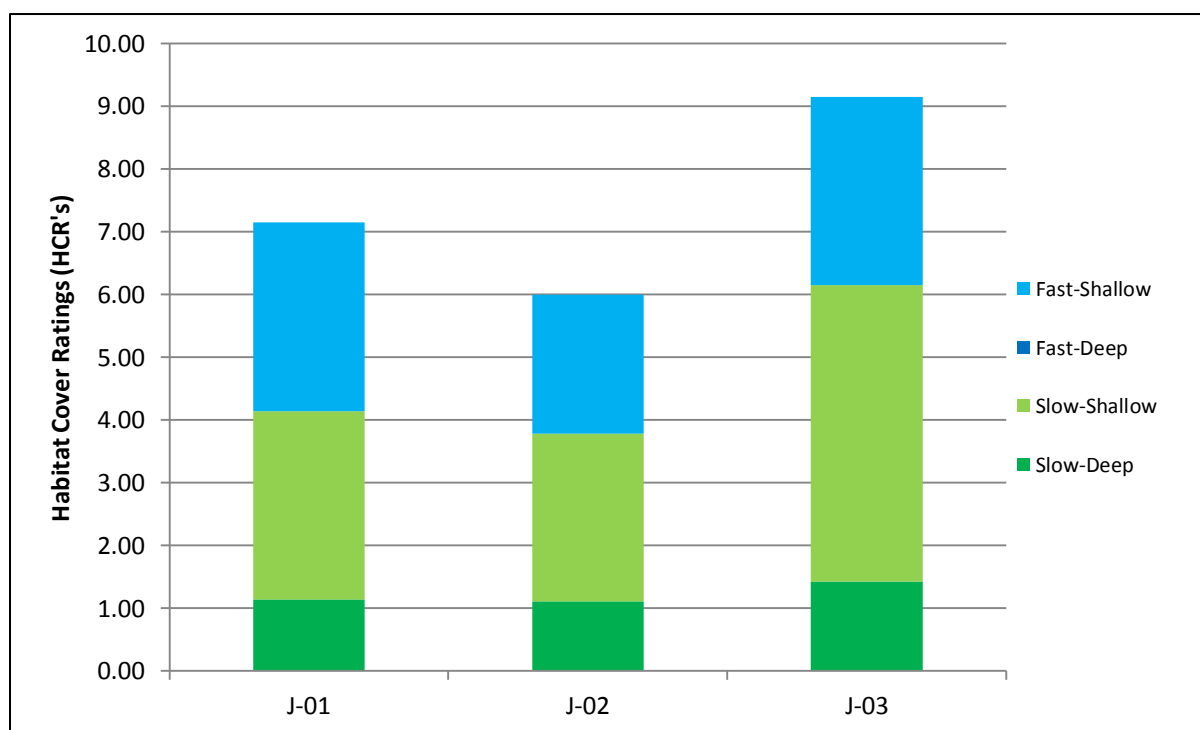
Figure 4.6.2 Availability and diversity of cover for fish at different sampling sites (August 2017)

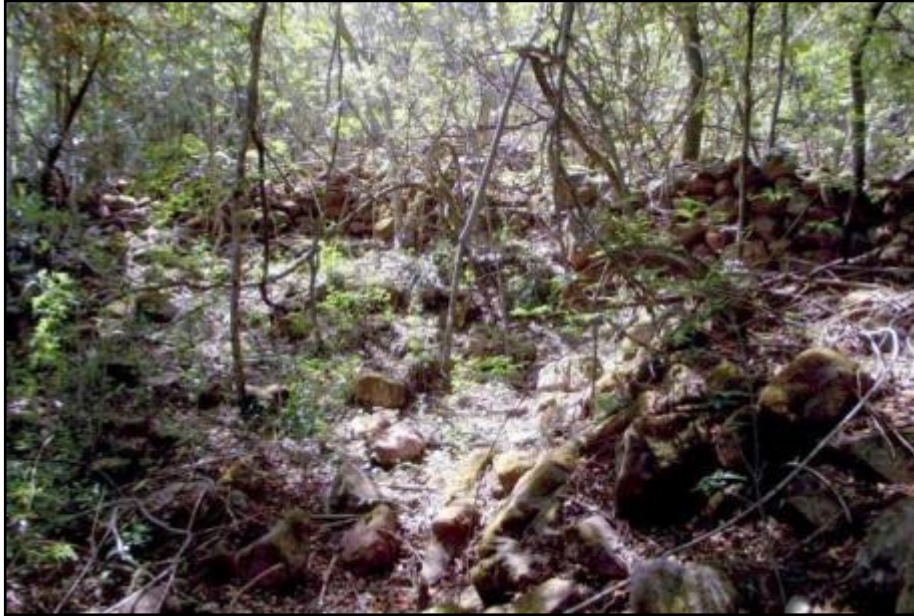
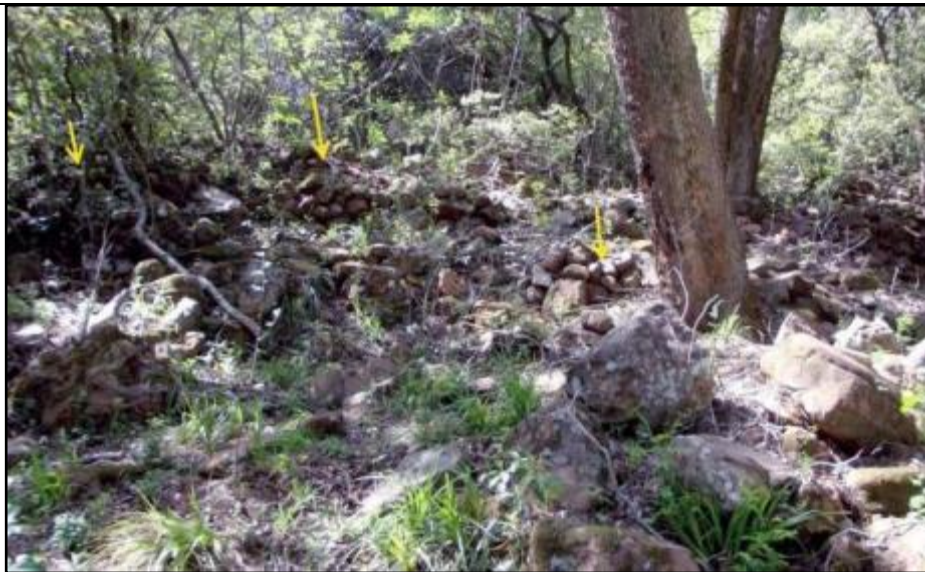
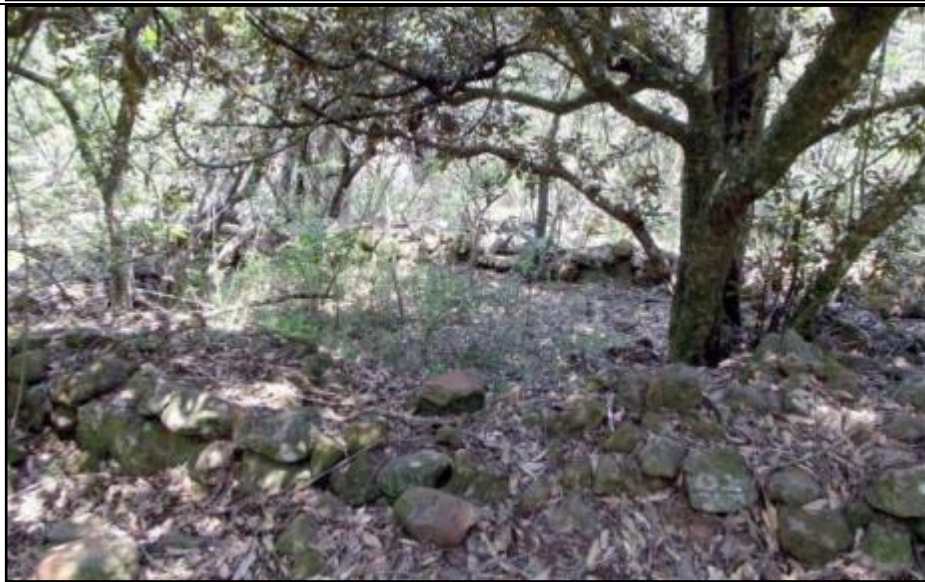
Photo 4.9.1 Photos of typical stonewall structures

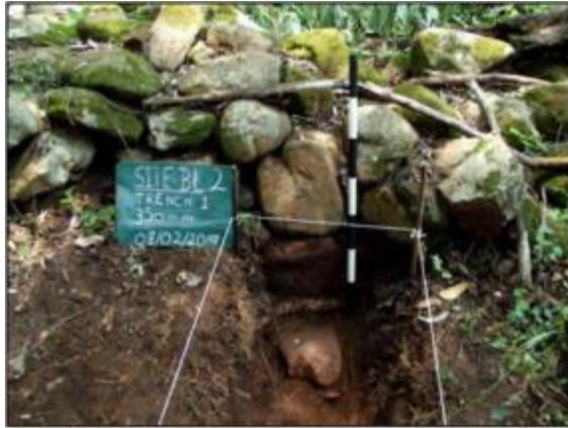
Trench BL 2-1. The trench reached sterile soil at 350mm which was well below the foundation of the wall.

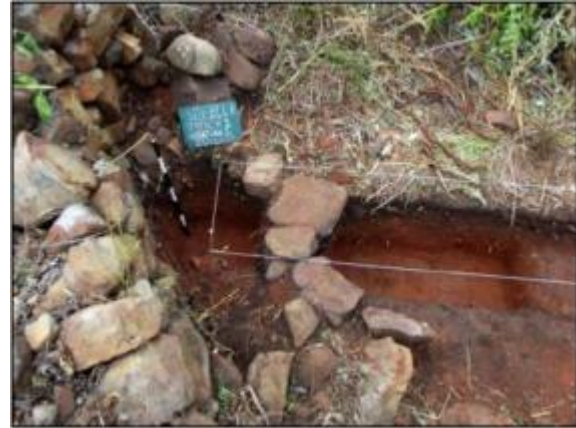
BL 4A-1. The trench at a depth of 450mm where it joins the wall. Rocks which tumbled from the wall are exposed. At this level the red clay soil continued and reached a sterile bottom.

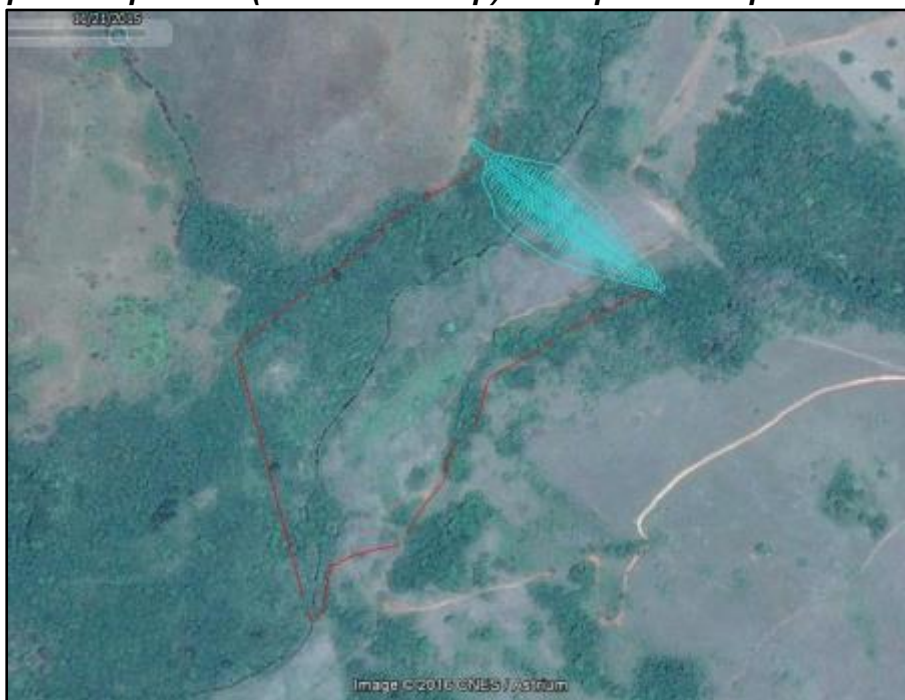
Figure 6.3.2 Preferred dam wall site and footprint area - full supply level (FSL)
